Assessment of a Dynamic Watershed via Field Studies and GIS-Based Erosion Model

William M. C. Whitman, Shahram Khosrowpanah, Mark A. Lander, Ujwalkumar D. Patil, Joseph D. Rouse. Assessment of a Dynamic Watershed via Field Studies and GIS-Based Erosion Model. *Hydrology*. Vol. 6, No. 3, 2018, pp. 88-99. doi: 10.11648/j.hyd.20180603.12

Abstract: This paper presents a one-year-long study of the baseline hydrologic conditions of the Geus Watershed in the tropical island of Guam, through field observations. Data analyses show a strong correlation between stream level, turbidity, and rainfall within the watershed, suggesting a highly dynamic nature of Geus watershed. Field data were then used to create a stage discharge curve, which increases the efficiency of future watershed management by providing an estimate of stream flow from a simple measure of water level. The supplemental analyses based on the test results of soil samples and a GIS-based erosion model identified areas within the watershed with higher contributions to erosion potential. In addition, synthesis of the information in this watershed study will allow for future recommendations for effective and sustainable watershe

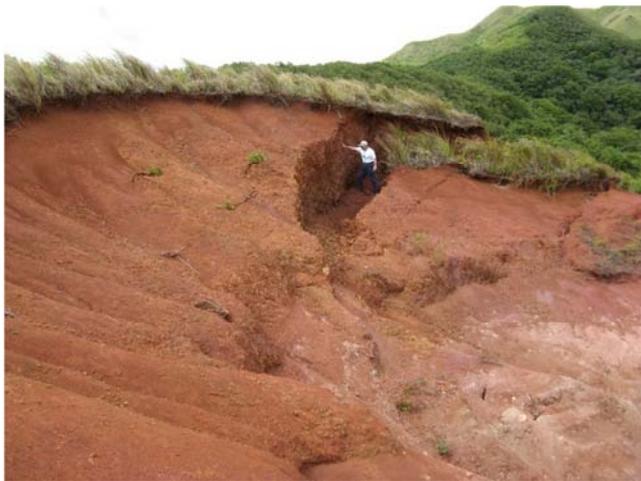
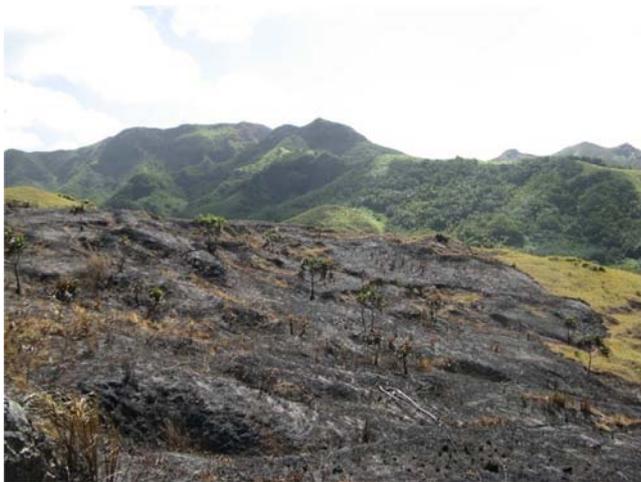
Figure 2. (a) Badlands atop the Pigua Ridge in Merizo, southern Guam; (b) Burned Savanna along the Geus Slopes in southern Guam.

Field visitations were conducted on a weekly basis from December 2013 through January 2015. During each visit, potential elements that may contribute to erosion and sedimentation that were observed were documented. These include vegetation types, Badland locations, slope and topography, and fires or other human activities (Figures 9 and 10). In addition, aerial surveys were conducted to observe land coverage and identify areas with more potential

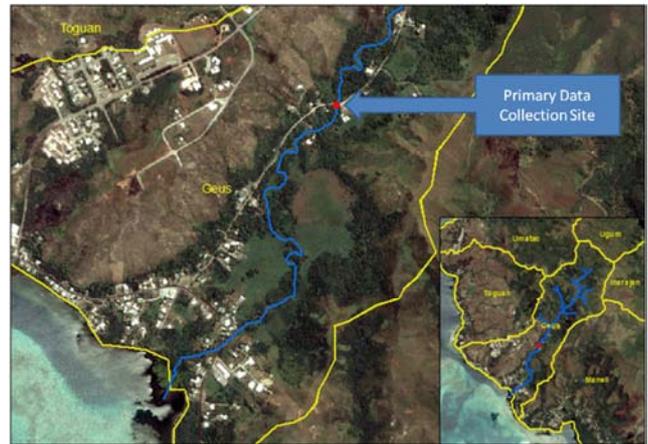
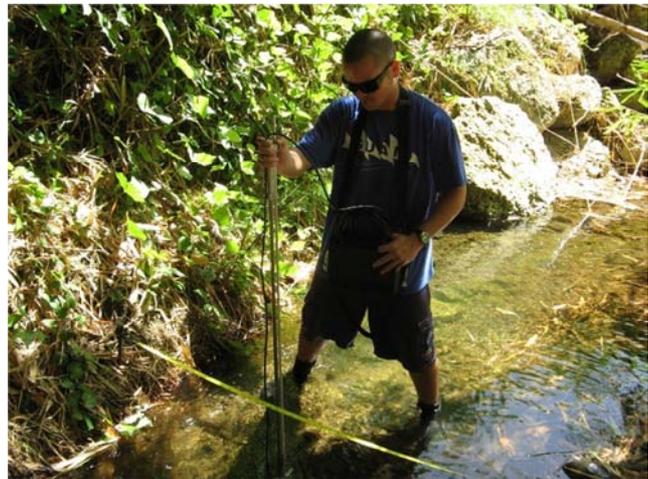
Figure 3. (a) Location of the hydrologic data collection station in the Geus River; (b) Stream flow measurement in the Geus River in southern Guam.

Stream flow was measured close to the primary data collection station during weekly site visits (Figure 3). A Flow-mate™ Model 2000 Portable Flowmeter was used to collect readings (in cfs) along a transect set perpendicular to flow direction. A correlation between total flow and stream level over time produces a discharge rating curve.

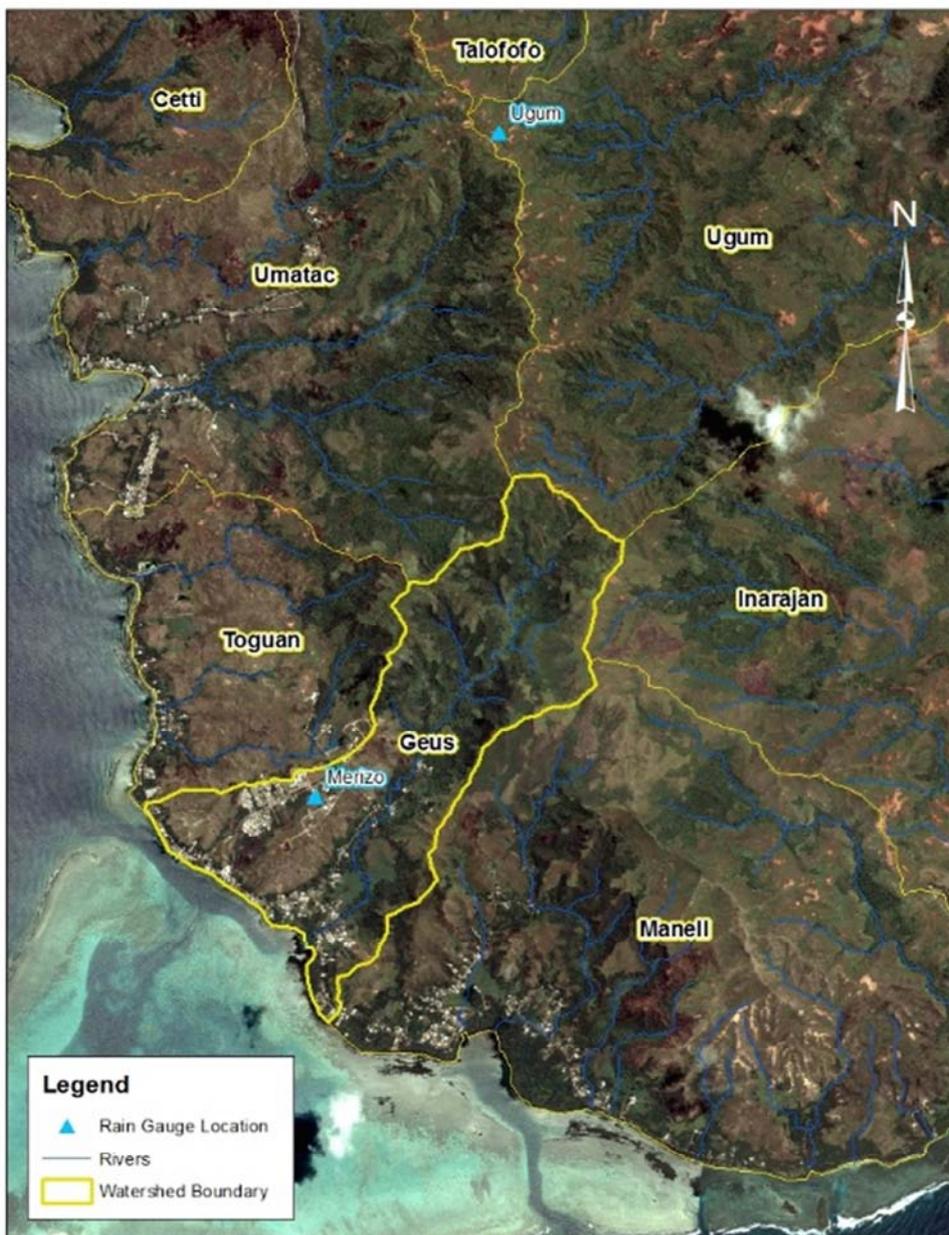
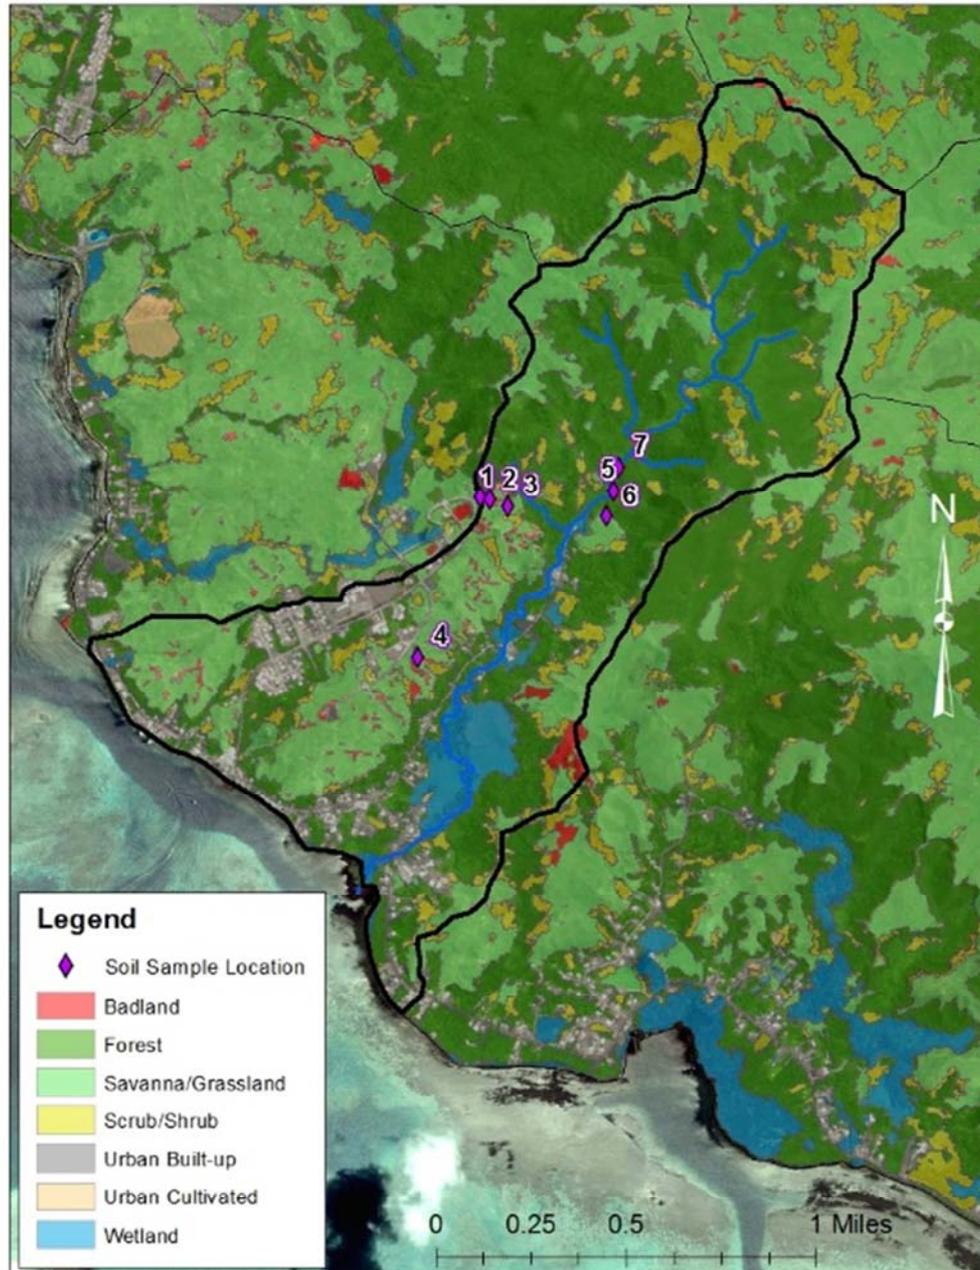
Figure 4. (a) Rain gauge locations in and around the Geus Watershed in southern Guam; (b) Soil sample locations within the Geus Watershed in Southern Guam.

were also used from a rain gauge located in the Ugum Watershed (Figure 4). The rain gauges use two tipping buckets that collect water as it falls, recording each time the tipping buckets are activated representing a specific quantity of rainfall (0.01 in per tip).

Soil samples from seven locations were randomly selected and tested in the soil lab to identify the various soil types represented in the Geus Watershed (Figure 4). Samples were collected as composites from sample locations selected based on exposed soil observations or dominant vegetation types. Four samples were collected along the upland ridge including areas consisting of the more prominent Badlands and grasslands. Three samples were collected in the interior of the valley and along the River where more forest vegetation dominates.

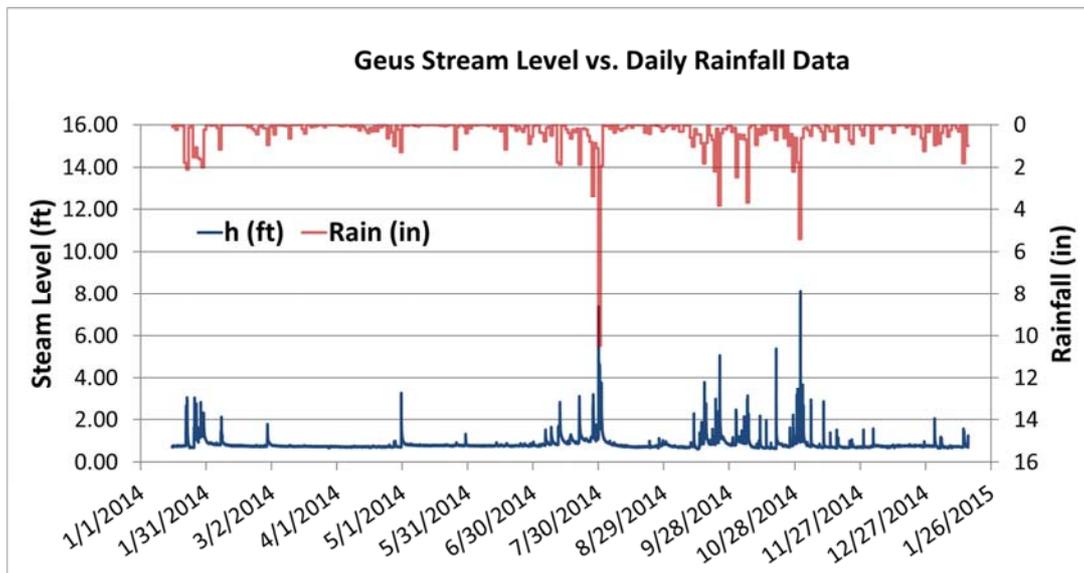
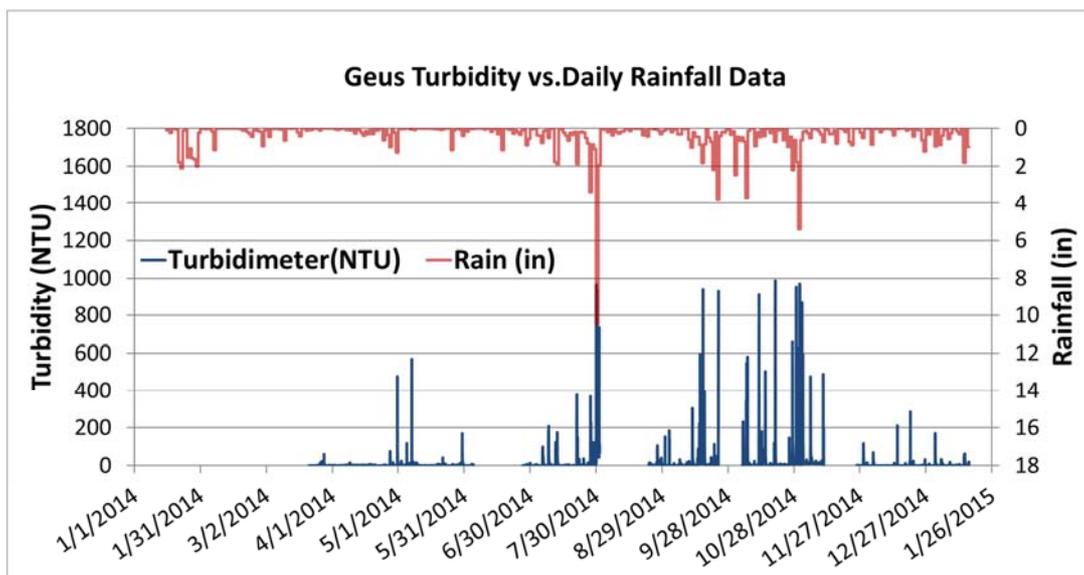
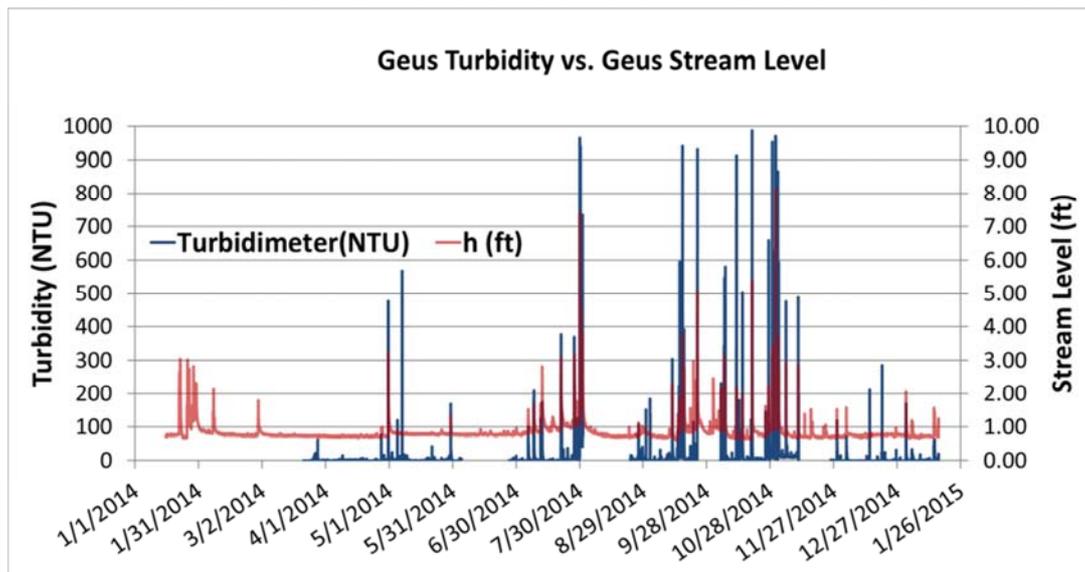
Figure 5. (a) 5-Minute stream level and daily rainfall totals; (b) 15-Minute turbidity readings and daily rainfall totals; (c) 15-Minute turbidity readings and 5-minute stream level.

This was consistent with the typical rainy season period [15]. Based on the data, it appears there is a strong correlation between stream level and rainfall in the Geus Watershed (Figure 5a). In general, when daily rainfall averaged one to two inches, the stream level increased on the order of one to two feet. During heavier rain events, with daily totals reaching almost four to five inches, stream level showed significant spikes upwards of four to five feet depending on the intensity of the rainfall. There also appeared to be a strong correlation between turbidity in the Geus River and rainfall (Figure 5b). This observation is supported by overlaying stream level with stream turbidity measurements (Figure 5c). As a result, it was evident that the intensity of the storm was a key factor influencing erosion and runoff as indicated by levels of turbidity.

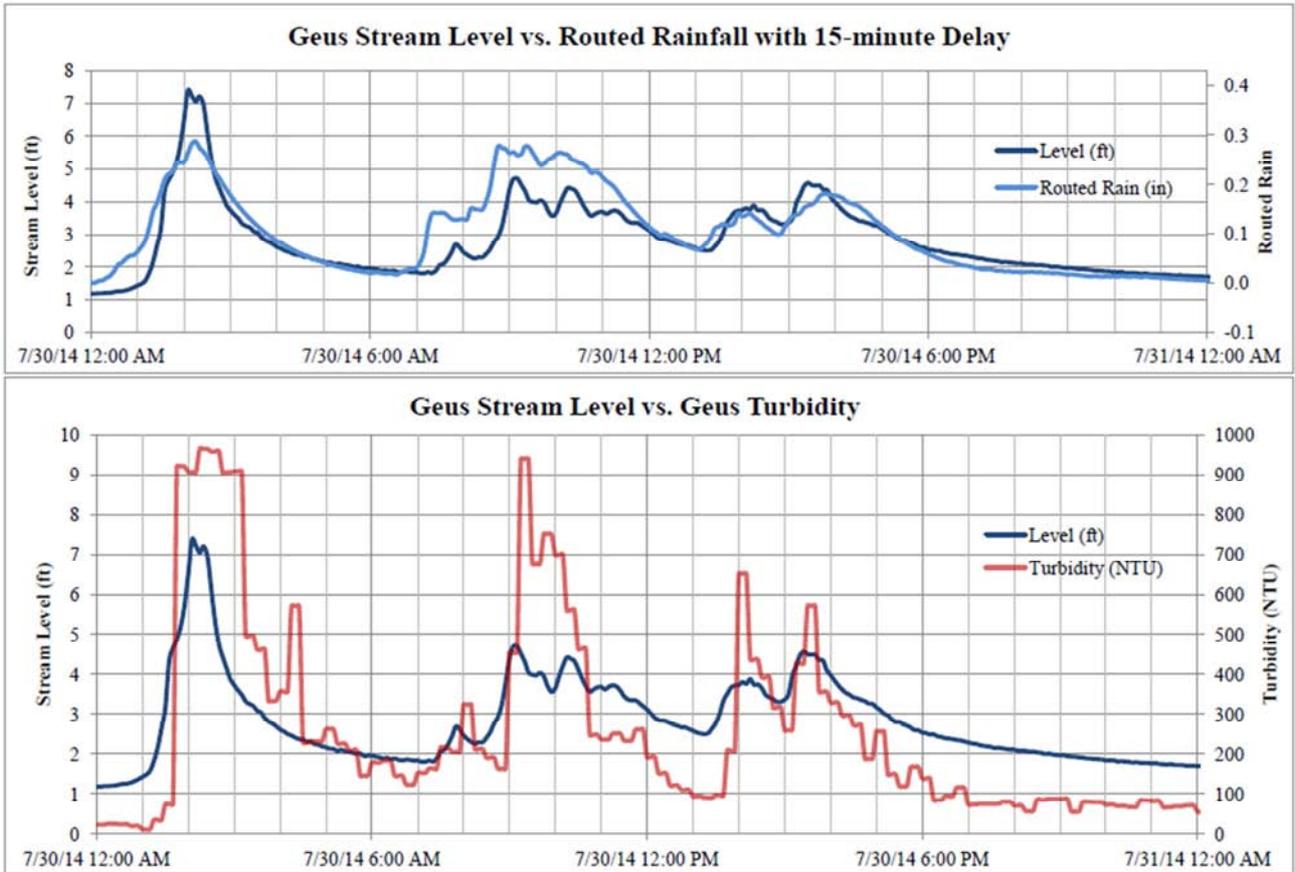
Figure 6. Routed rainfall & 15-minute turbidity, versus 5-minute stream level data.

The dynamic response of the Geus watershed was also evident as rainy season storms produced high velocity flow events with maximum recorded turbidity readings. In fact, the largest rain event (Tropical Storm Halong) on July 30, 2014, caused so much sediment build-up around the turbidimeter that it affected the validity of the data until manual cleaning was completed. During this storm event the maximum stream level recorded was 7.0 ft at 2:05 am, and the duration at that height was not longer than that 5-minute interval. During that spike, stream level was greater than 6 ft for 30 minutes, greater than 5 ft for 40 minutes, and greater than 4 ft for 70 minutes. Based on this data, the stream level doubled, then came back down (from 3.5 to 7 ft) in less than an hour and a half (Figure 6).

am to 2:30 am (Figure 6). Turbidity above 900 NTUs lasted about an hour and a half, and significant increases were observed when stream level rose to greater than three feet. Routed rainfall data at a 15-minute delay correlated well with the 5-minute stream level data (Figure 6). The coefficient for rainfall routing best fits the stream level response with a delay of 15-20 minutes between peak rainfall and peak stream level. This storm event is one example that shows how dynamic the Geus Watershed is.

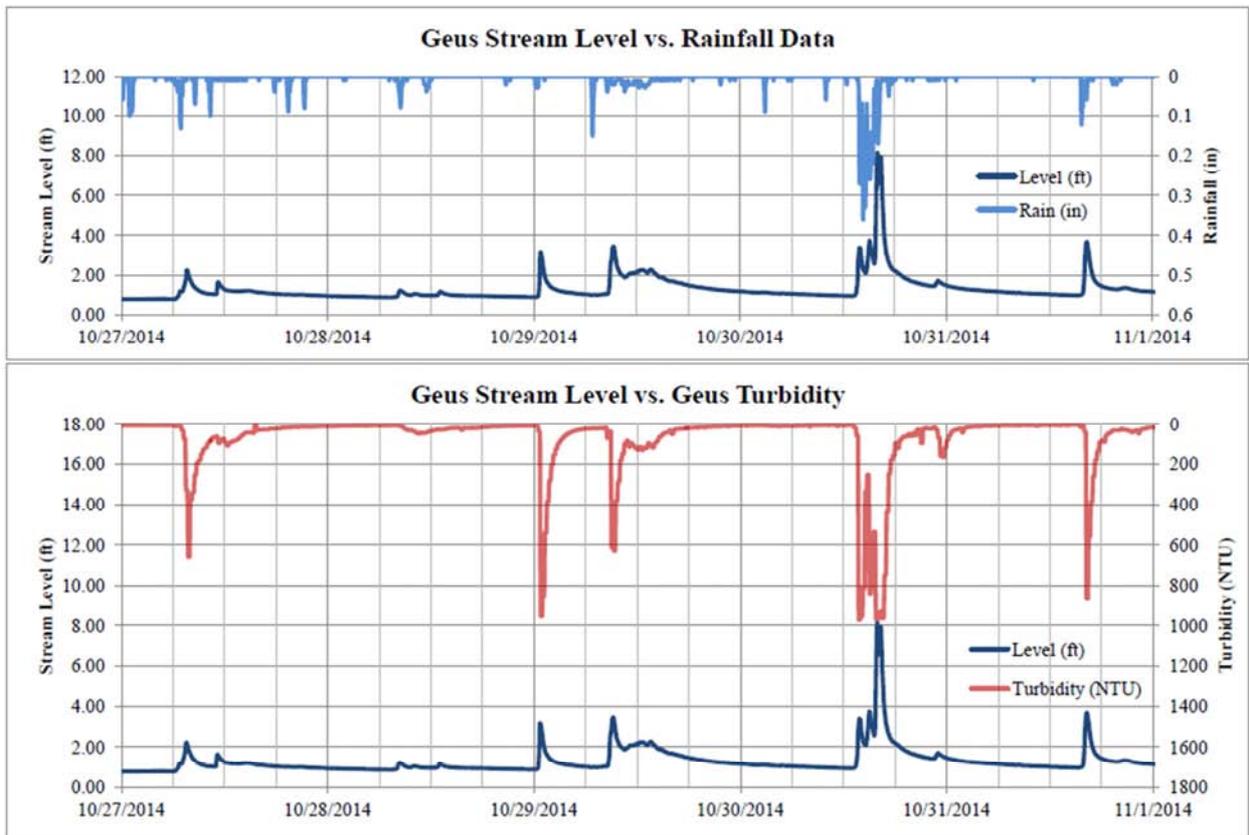
Figure 7. 5-minute rainfall & 15-minute turbidity, versus 5-minute stream level data.

A time series during a period of storm activity in October 2014 also depicts the response time between rainfall, stream level, and turbidity (Figure 7). Based on the dimension of the Geus Watershed, the river floods appear to last less than a couple of hours. This shows that the dynamics of river runoff and suspended sediment fluctuated at a time scale of hours or less. Therefore, this is an important consideration in understanding the magnitude of sediment plumes versus the long-term erosion rate.

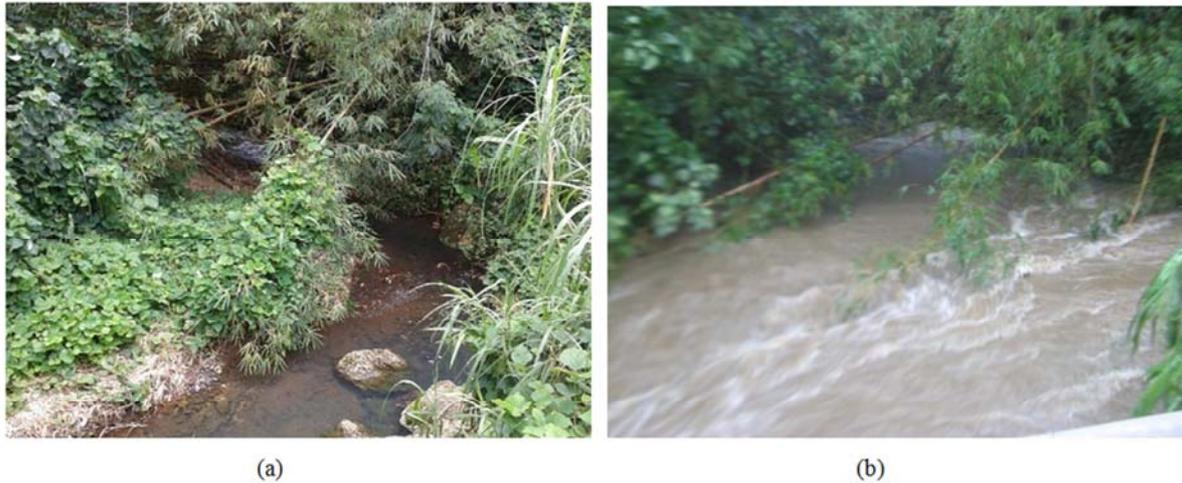
Figure 8. Geus River conditions (a) before and (b) during Tropical Storm Halong (July 18, 2014 and July 30, 2014, respectively).

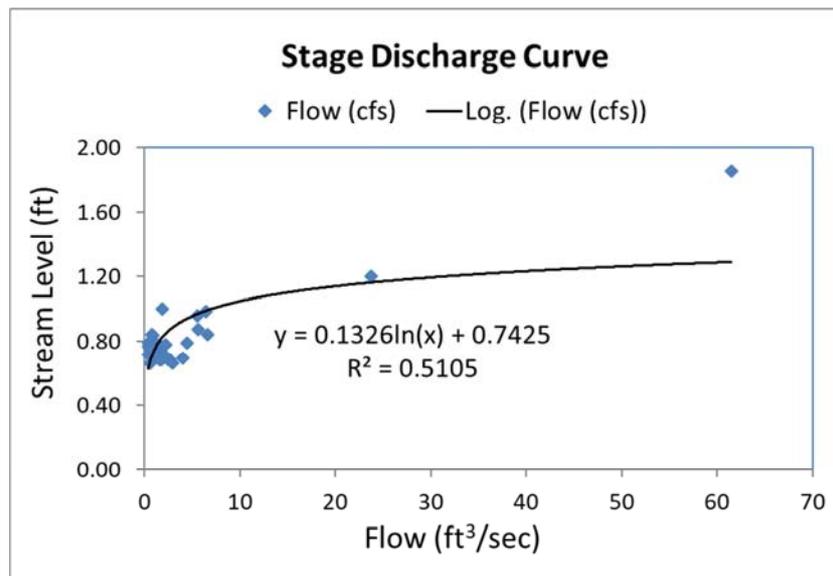
Figure 9. Preliminary Stage Discharge Curve for Geus River based on data collected.

The preliminary stage discharge curve is presented below (Figure 9). The stage discharge curve will gain greater accuracy as more data under a range of flow regimes continues to be collected over the course of several years or more.

This watershed management tool will provide an estimate of flow based on measured stream levels.

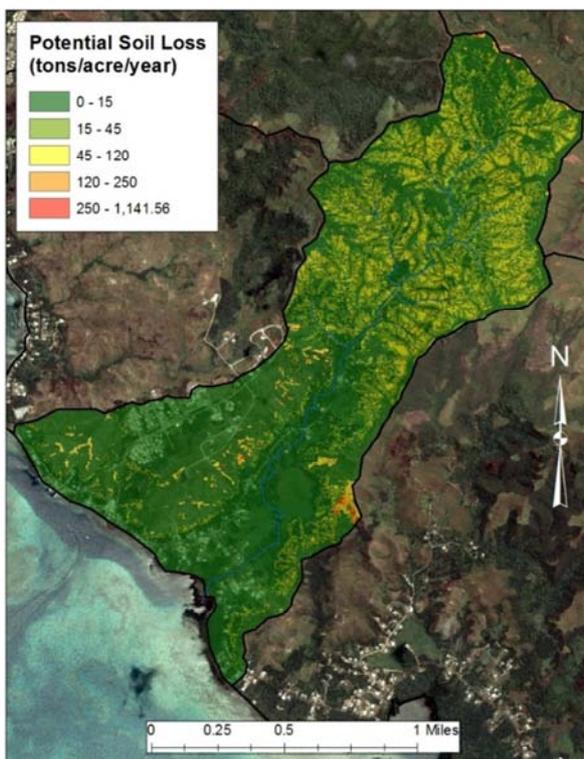
Figure 10. Results of GIS-Based Erosion Model showing areas within the Geus Watershed that have a higher contribution to erosion potential.

The results of the GIS-based erosion model are shown in Figure 10. Based on the results of the model, the mean annual rate of soil loss for the entire watershed is an estimated 16.78 tons/acre/year, with a standard deviation of 26.77 tons/acre/year.

The range of estimated annual soil erosion potential (maximum of 1,141.56 tons/acre/year) is considered an estimate that could be further evaluated based on empirical data. However, this data provides a general understanding of areas within the watershed that have the potential to contribute the most to soil erosion. The Badland locations along the ridges appear to be hotspots contributing the most to soil erosion (Figure 2). However, proximity to the river or its tributaries is an important factor in determining the likelihood that sedimentation can impact downstream communities. Therefore, the steep terrain at the back of the valley appears to also have some level of increased contribution to erosion based on this model.
